## ***Periodic inspection of integral particulate and debris strainer.***

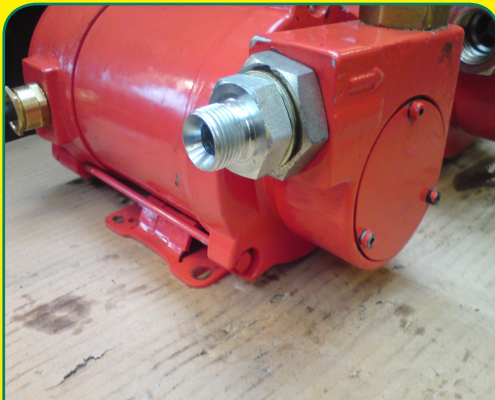
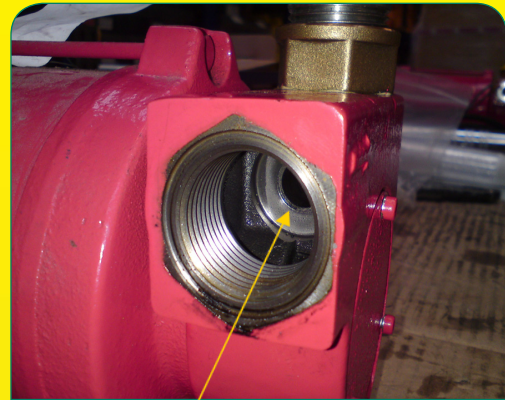
Remove pump inlet hose & unscrew integral filter housing noting position of seal and orientation of bypass valve spring.

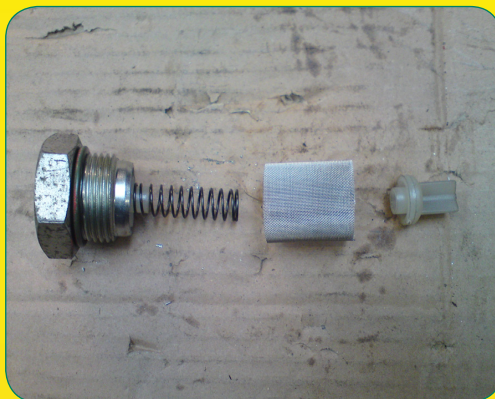
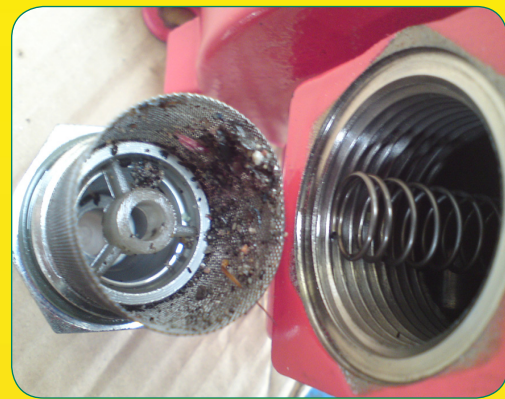
Bypass valve

When removing this assembly be aware of any debris build up as shown above. It will only take a small amount of this debris to permanently damage the vanes in the pump. Re-fitting is the reverse of removal.

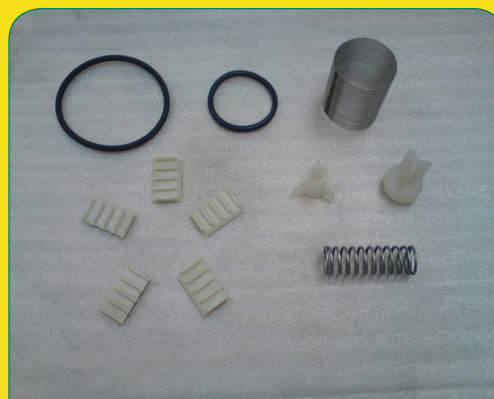
Included in service kit; Pump body cap seal, strainer body seal, mesh strainer, bypass valve assembly, set of five vanes.
